08 October 2004

AIRWORTHINESS ALERT

& request for information 2004-1

SZD-50-3 PUCHACZ

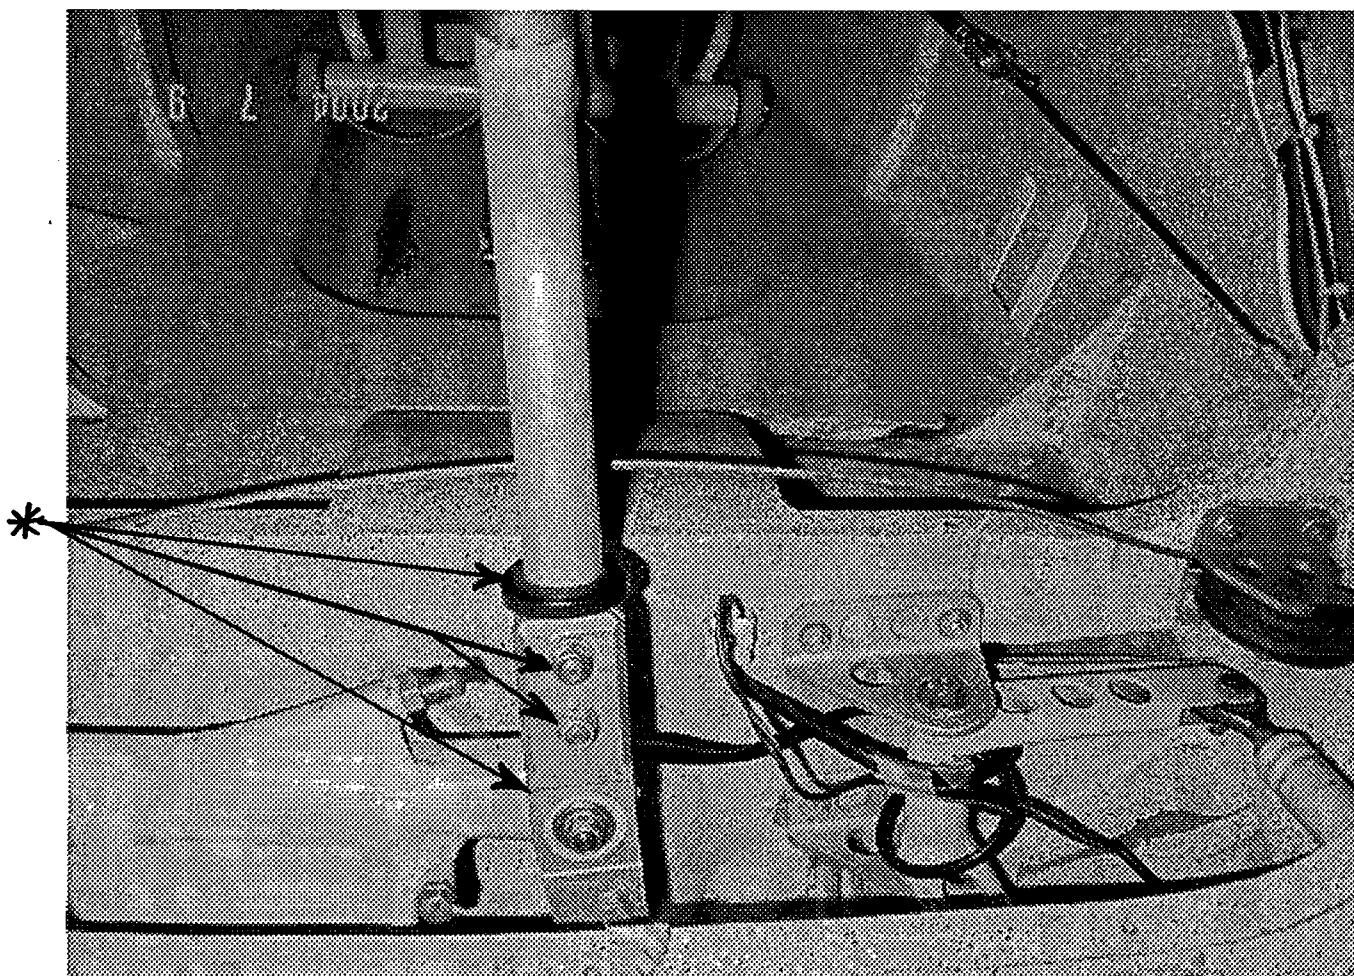
1. Before further flight, inspect the aircraft for cracks in the area shown on the attached drawing. Be imaginative, as we are not sure yet which part actually failed.
2. Ground the aircraft, pending rectification, if cracks are found.
3. Notify results of inspections to GFA without delay (whether cracks found or not).
4. Inspection to be performed by or under the supervision of a person holding a current GFA Airworthiness Authority endorsed for Inspection for issue of a Maintenance Release or higher.

POTENTIAL CRACK SITES

7. If any cracks are found the aircraft is to be withdrawn from service until replacement parts have been fitted. If no cracks are found the aircraft may be returned to service.
