GFA AIRWORTHINESS DIRECTIVE

- TYPE AFFECTED:** SZD-50-3 PUCHACZ. ALL SERIAL NO'S.
- SUBJECT:** Failure of Pushrod End Bearing in elevator circuit.
- BACKGROUND:** A failure occurred in the elevator control circuit which resulted in total loss of elevator control from the front cockpit. Fortunately the aircraft was being flown dual and the rear pilot landed the glider safely. Had the failure occurred during solo flight or with an inexperienced person in the rear the outcome could have been serious indeed.

SZD-50-3 PUCHACZ AD-623

Guidelines for performing Daily Inspection in accordance with AD-623.

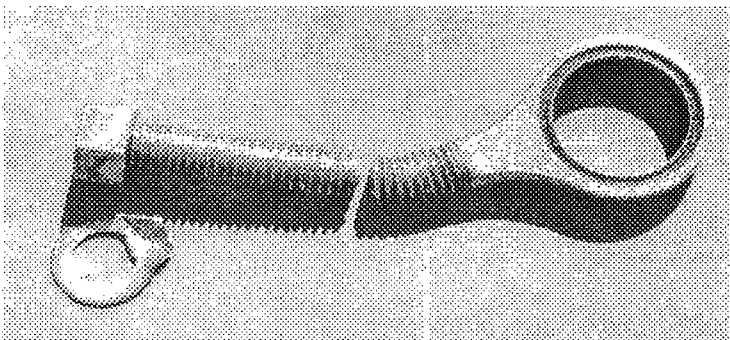
- FINDINGS:** On inspection it was found that the rear rod end bearing of the elevator pushrod which connects the front and rear control columns had broken at the point where the threaded portion enters the locknut. The pushrod was therefore completely detached from the rear stick.

- Continuing investigations indicate that the end bearing which failed was mechanically damaged well prior to the failure, and although not yet positively established, it is believed that the end bearing was bent by a person treading on the push rod or end bearing while entering or exiting the rear cockpit; not by loads imposed during flight.

Broken rod end bearing showing extent of bending prior to failure. Note profile of locktab to suit keyway.

- ACTION REQUIRED:** **"ACTION A": Before further flight** the following checks must be performed.
1. The pushrod connecting the front & rear control columns is to be examined critically. This is the pushrod which runs down the left side of the cockpit. Remove the rear rod end from the pushrod and inspect the threaded area for bending or cracks using a 10X magnifier.

4. Any suspect rod ends must be replaced with serviceable components before further flight.

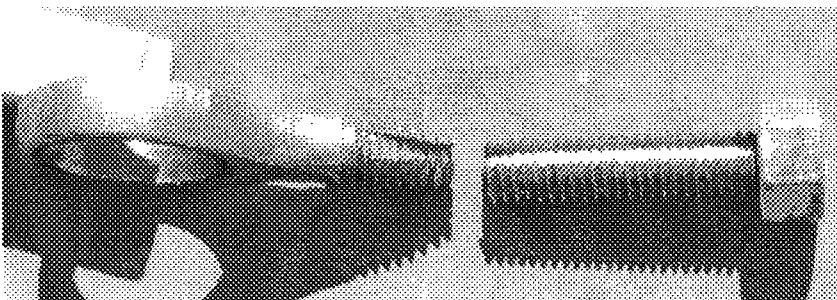
Broken rod end bearing showing keyway.

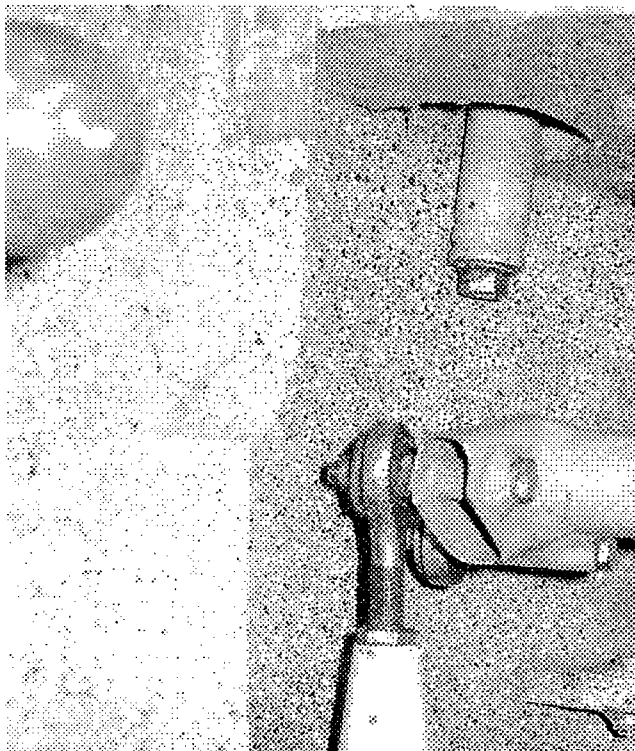
View looking vertically downwards, left side of rear cockpit floor, showing edge of rear control column cross member and rear end of the elevator pushrod where the rod end bearing failed. Locknut and tab washer are still in place. Trim knob is visible in upper left of picture.

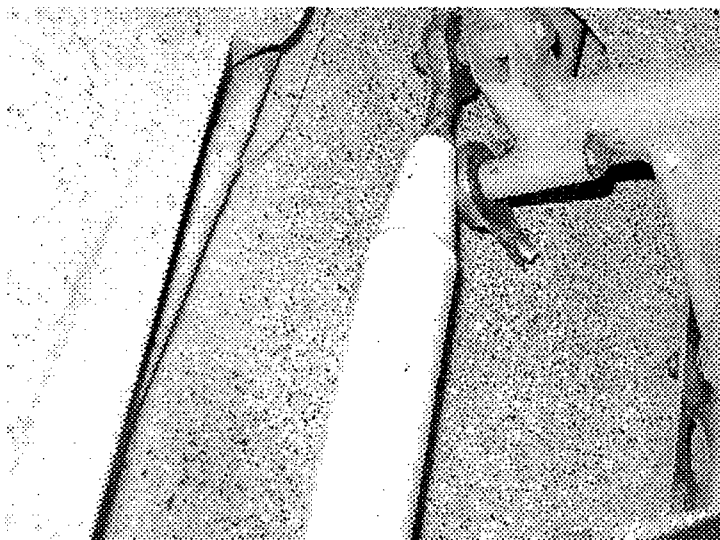
View from rear pilot's seat showing broken rod end bearing and its attachment point to the rear control column cross member.
