THE GLIDING FEDERATION OF AUSTRALIA INC.

AIRWORTHINESS ALERT 2009-3.

Nimbus 4DM & Solo powered self launching gliders

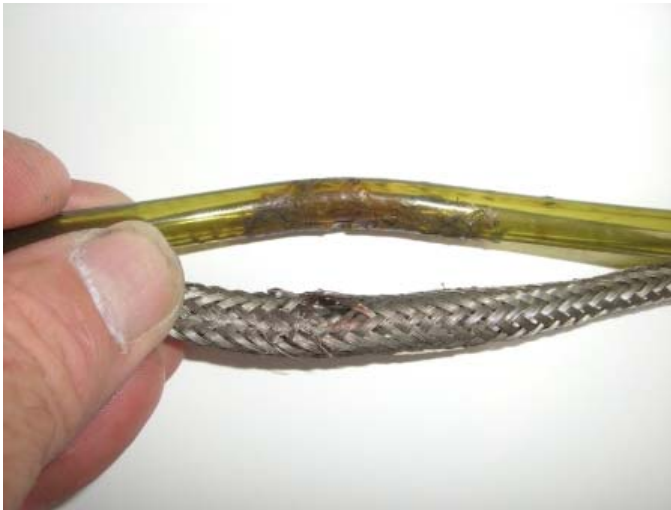
Yesterday the operator of a SOLO powered Nimbus 4DM reported a severe fuel leak which occurred in flight. Upon landing fuel was seen to be leaking from the drain hole under the engine bay and there was significant fuel streaking along the bottom of the fuselage. Fortunately, the leak did not result in a fire. This aircraft has had 57 launches for a total of 10.47 engine hours since new in 2005.

The line is protected by a metal braid, but this gives little protection from heat and investigation revealed severe heat degradation of the fuel line underneath the damaged area of the braid. This occurred where the fuel supply line passes between the starter motor and engine crankcase, and is nearly impossible to detect without disassembly. It is not known at this stage whether SOLO engines other than the 2 625 series are affected.

If you have a SOLO powered self launching glider it is strongly suggested that you check the routing of the fuel lines and if the lines go between the starter motor and the crankcase you may well have a serious problem about to develop.

Before further flight:- check the lines under pressure (engine STOPPED, electric pumps ON). Check for abrasion of the braid; some disassembly will be needed to do this thoroughly. **If any abrasion of the braid is evident the line is suspect and it should be replaced immediately.**
